# Analysis of damage to coastal dikes by tsunami

—Damage analysis to discover the direction of future countermeasures—

River Department, Coast Division

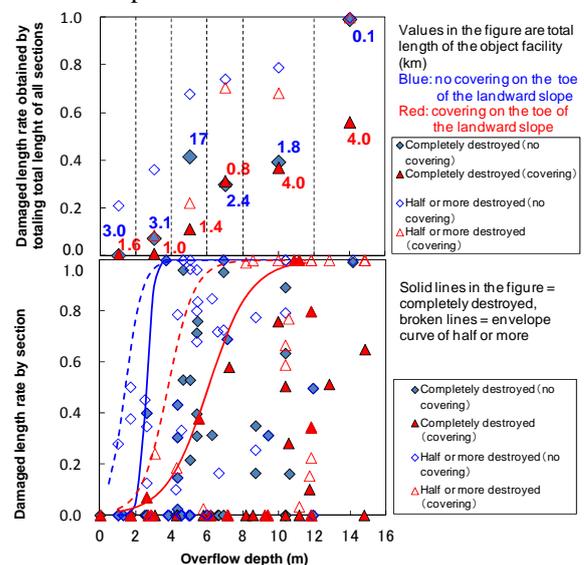
Figure 1 shows the relationship of tsunami overflow depth with damaged length rate (percentage of total facility length which is damaged) in 118 sections of coastline dikes with three surface-armoring. There were cases where 100% of the dikes were totally destroyed at an overflow depth of about 3m, while in other cases, even at overflow depth over 10m, the damage length rate was 0%, revealing that even under the same tsunami height, the state of damage differed greatly according to section (bottom part of Fig. 1). This could be caused by diverse on-site conditions or facility structures, and it means that a structure which has been effective on one coastline might not be effective on another coastline. It will be necessary to collect as many cases as possible, and clarify the variation in the data, to carefully study ways of handling the data according purpose of use. To scientifically discuss differences in the state of damage, the average values which also consider differences in the length of each coastline (top of Fig. 1) are also important, but in order to protect human lives at all cost, it is necessary to assess safety of

structures more strictly than the envelope curve shown in the bottom of Figure 1.

Regarding the relationship of covering/non-covering of the toe of landward slopes with the total destruction length rate, the results of totaling data for each section by overflow depth from less than 2m to 4m etc. reveal that within an overflow depth range from 2 to 6m, the damaged length rate was lower when the toe of the landward slope was covered (top of Fig 1). It is necessary to conduct experiments to clarify why there were no differences at and above an overflow depth of 6m.

Figure 1. Differences in State of Damage of Coastal Dikes with Three Armored Surfaces With/Without Covering on Toe of the landward Slope
