## Reports on Damage to Buildings, etc. brought about by the Tornado which hit Tsukuba, Ibaraki on May 6, 2012

OKUDA Yasuo, Research Coordinator for Disaster Mitigation of Buildings (Dr., Engineering)  
Research Center for Disaster Management

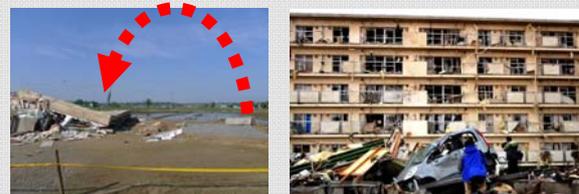
Among the buildings made of wood, there were various degrees of damage such as completely overturned buildings, removed superstructures, collapse, inclination, blown roof framework, blown roofing materials, broken windows and aluminum sash. Particularly the case of whole wooden houses ripped from their foundation and overturned (Photo-1) was unprecedented in our country. The mechanism that caused the damage was studied and the wind velocity at the outset of the damage was estimated.

Although there were no reports on direct damage to building complexes made of reinforced concrete hit by the tornado, damage to balcony rails, windows and sash was caused by the objects brought by the tornado (Photo-2).

Overturned building (Photo-1) Wind pressure of the tornado and hit by flown objects (Photo-2).
