Damage Investigation of Buildings or the like by Tornadoes Occurring on September 2, 2013

OKUDA Yasuo (Dr Eng.), Research Coordinator for Disaster Mitigation of Building
Research Center for Disaster Management
ANDO Koji (Dr. Eng.), Head
KABEYASAWA Toshikazu (Dr. Eng.), Researcher
Standards and Accreditation System Division, Building Department
NAKAGAWA Takafumi (Dr. Eng.), Senior Researcher
Housing Production Division, Housing Department

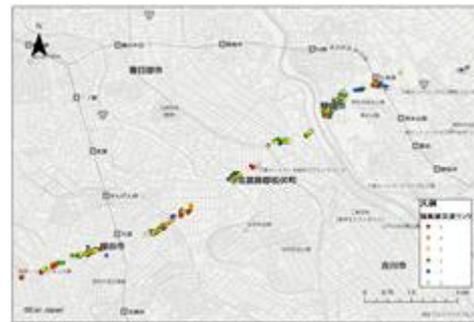
We carried out appearance inspections for 593 buildings in total, targeting areas which seemed to have especially momentous damage within the scope of investigations and judged the damage degree in view of damage of structural frames/roofs/exterior members or the like based on the gale damaged degree ranking (see chart). In this investigation, collapsed damage of 17 buildings (Rank 5) was confirmed in total. In addition, we have found that damage by tornadoes were more or less

distributed in a linear fashion.

Figure Distribution of gale damage degree rank

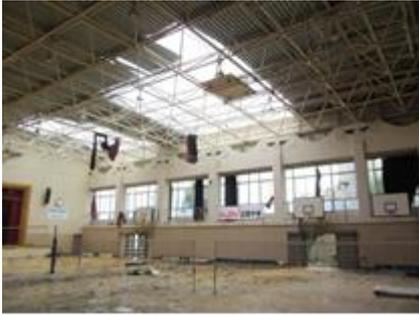
The damaged gymnasium of an educational facility has a flat surface size of 20m x 30m and height of about 10m, and the roof is a cubic truss with a reform construction implemented in 2005 (Photo1). For fixing the roofage to the main building, screws were used. The metal roof is partially twisted up due to breakup at connecting part between the main building and roofage and the broken part was about 25% of the total area. Moreover, part of the roof was bent upward. Furthermore, the fall of slope roof is confirmed in addition to the destruction of steel sheet roofage and the main building.

Photo 1: Damage in educational facility A
Gymnasium

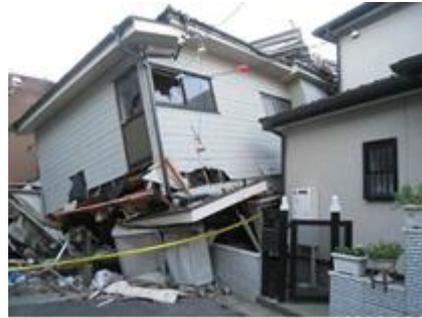
The timber house illustrated in Photo 2 shows the possibility of destruction due to the upper structure of a building blown from the neighboring area. As an example of the collapse of a whole structure, we corroborated a two-story house had its ground floor collapse and upper structure blown away leaving its foundation. Other than these, (1) damage to the roof truss, (2) damage to openings/exterior finishes and (3)

Photo 2: Collapse of upper structure in timber
housing
