# Field surveys of damage to buildings and foundations from the 2014 northern Nagano earthquake

NAKAGAWA Takafumi (Ph.D (Agriculture)), Senior Researcher  
Housing Production Division, Housing Department  
ARAI Hiroshi(Ph.D (Engineering)), Senior Researcher  
Structural Standards Division, Building Department

(Keywords) damage investigation, wooden house, foundation, Kamishiro, the 2014 northern Nagano earthquake

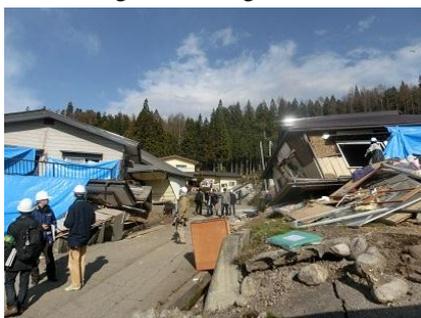
Photo 1: Collapsed houses

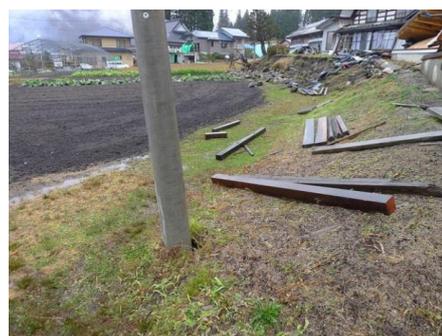
The survey of ground and foundations has revealed that a number of stone and retaining walls were heavily damaged or overturned in the Horinouchi district, which is a south-facing slope terrace. Many power poles were also shifted about 5-30 cm and inclined southward in the district. These indicate that strong ground motions could have been predominant in the north-south direction during the main shock.

Some documents reported that this district was placed near the shore of a large lake before, suggesting that the surface strata consist of soft soils and their geophysical conditions could vary with locations on the slope in the district. And by surveying soil investigation data, we will study the relationship between the structural damage and ground characteristics in the district.

Photo 2: Stone walls and power poles damaged southward
