Technical Support for Safety Check and Recovery of Dams Affected by the Kumamoto Earthquake

KONDO Masafumi, Head, TANAKA Koji, Researcher

Large-scale Hydraulic Structure Division, River Department

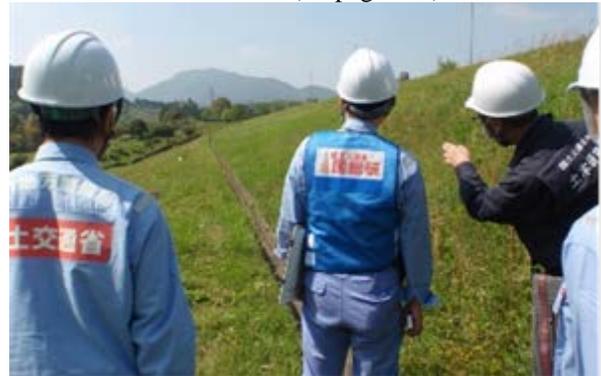
In the investigation of Midorikawa Dam (Photo 1), we found a crack in the paved surface of the road on the crown of the side dam (rockfill dam with a central earth core, 35.0 m high), but the width of the crack was relatively narrow and there was no crack in the upstream / downstream direction, squeezing on the upstream / downstream face, etc., which could cause a problem with the water cut-off function of the dam. In the displacement measurement, slight subsidence was observed in the dam body but no abnormality concerning water leakage was found.

Photo 1: Investigation of Midorikawa Dam (Downstream face of the side dam)

From the results of the investigation above, it was determined that deformations confirmed with both dams would not immediately cause any problem with safety. However, since some deformations were found, we made discussion and gave advice on the emergency measures for preventing infiltration of rain water, etc. and important monitoring objects for the present, etc. Then, administrators are striving hard to fully restore both dams. NILIM is continuously providing technical advice on detailed additional investigation including identifying of the deformed area in the dam body, recovery method, etc. in collaboration with Public Works Research Institute. We hope that both dams as well as disaster stricken area will fully recover as soon as possible.

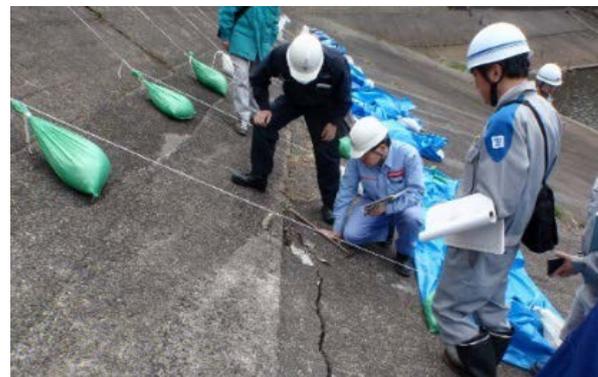
In the investigation of Jizobaru Dam (earth dam, 21.8 m high) (Photo 2), some deformations were confirmed, including subsidence of the crown of the dam body and crack opening on the concrete diaphragm wall in the upstream face of the dam body, but there was no deformation in the downstream face. Leakage slightly

increased from the amount before the earthquake but was stable, and there was little change in the water level of the dam reservoir (seepage line).

Photo 2: Investigation of Jizobaru Dam (Upstream face of the dam body)
