# Emergent Survey on the Disasters by the 2019 Boso Peninsula Typhoon, East Japan Typhoon, etc.

Emergency Survey Team consisting of National Institute for Land and Infrastructure Management, Public Works Research Institute, Building Research Institute, and Port and Airport Research Institute of National Institute of Maritime, Port and Aviation Technology

This paper reports as a quick bulletin the outline of damage, etc. caused by the 2019 Boso Peninsula Typhoon, East Japan Typhoon, etc. based on the emergency field survey by classifying the disasters by facility etc. Note that numerical values etc. reported in this paper include those as of the survey.

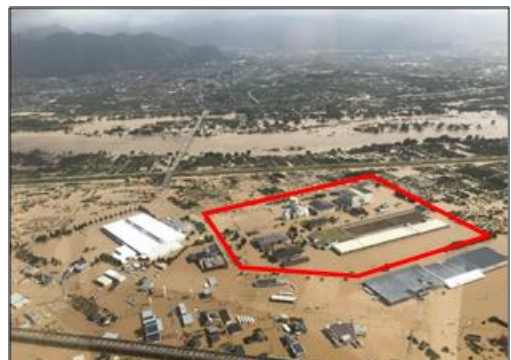
Treatment facility in the Chikuma River Basin Downstream Treatment Area has the treatment capacity of 69,000 m<sup>3</sup>/day, covering the treatment area of Northern Nagano-shi, Suzaka-shi, Obuse-machi, and Takayama-mura. Located near the JR East Japan Nagano Shinkansen Rolling Stock Center, the facility on the whole submerged due to the levee failure of the Chikuma River and its function stopped (Photo 1).

**Photo 1 Disaster in the treatment facility of the Chikuma River Basin Downstream Treatment Area**  
Photo source: Nagano-ken

After suffering the disaster and subsiding of the inundation, the facility resumed acceptance of sewage from October 19 and started disinfection operation. Then, after installing a temporary pump, the facility started operation with simple treatment (precipitation + disinfection).

For the future, the facility has been preparing for restoration, including restart of simple biological treatment in turn for each system.

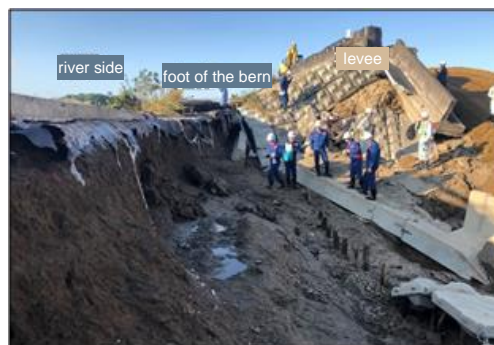
In the Yoshida River, a levee failure occurred in the section of about 100 m, located on the downstream side where the levee normal line turned toward the river side (Photo 2). In the back of the river side slope at the foot of the berm where the slope pavement is installed, a pool dug where the basic ground is deeply dug was formed and its ground surface was comprised of sediment that includes fine grained soil. Note that the CCTV video depicting the flooding at this point caught the flood flowing over the crest.

**Photo 2 Collapse at 20.9 kp on the left bank of the Yoshida River in the Naruse River System (Oct. 16)**

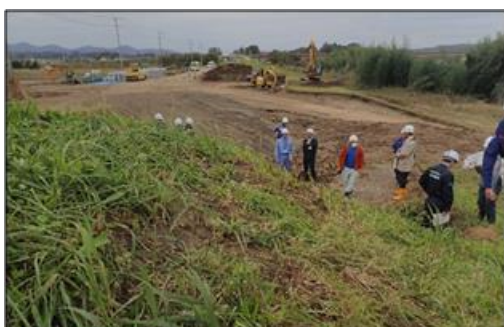
On all the sites of these 9 spots, a cofferdam was being installed in the emergency recovery work. In all the collapsed spots, trace of overtopping, far exceeding the design water level of the levee, was confirmed.

**Photo 3 Collapse at 28.6 kp on the right bank of Naka River (Oct. 18)**

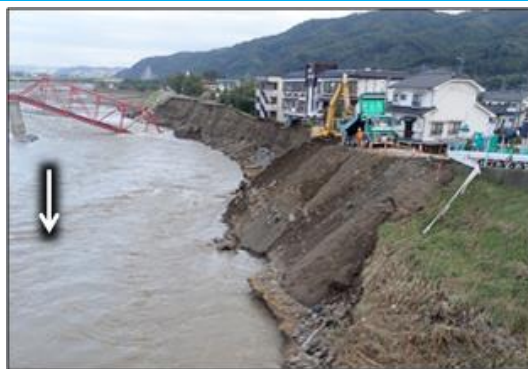
In addition, in the individual survey conducted on October 26, the spot where levee revetments were damaged and the bridge across the riversides fell was confirmed, although the measures for water colliding front, including installation of groyne, had been progressing in the area of Tomi-shi Umino site to Tanaka site, located in immediately upstream of the direct control section since it is located in the outer bank of the bend.

**Photo 4 Levee collapse at 104 kp on the left bank of the Chikuma River  
Situation of damage (Oct. 15)**

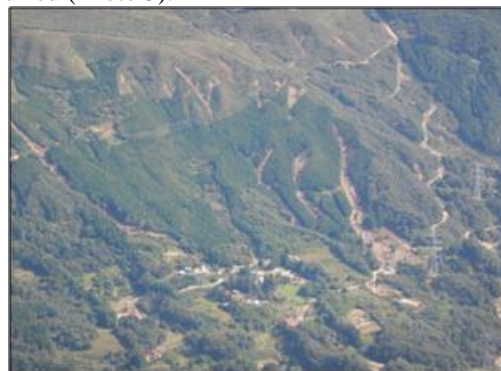
**Photo 5 Frequent slope collapse and debris flow  
(Igu-gun, Miyagi)  
Mawarigura Area, Marumori-machi, Oct. 17)**

Particularly, in Marumori-machi, Igu-gun, Miyagi, debris flow and surface failure occurred almost simultaneously and the riverbed rise and channel clogging resulting from runoff of a large amount of sediment also caused damage by sediment / flood inundation. As a factor of such damage, the rainfall, totaling 607.5 mm with the 60-minute maximum precipitation of 80.5 mm (Oct. 12, 19:30 to 20:30) is mentioned (AMeDAS: Hippo Observatory). In

particular, the 12-hour rainfall (517.5 mm), observed by the Observatory, was over two times the existing maximum rainfall. As another factor, the distribution of granites and granodiorites in the affected area is considered, which are also distributed in the areas of sediment / flood inundation caused by the 2018 West Japan Heavy Rain Disaster and the 2017 North Kyushu Heavy Rain Disaster.

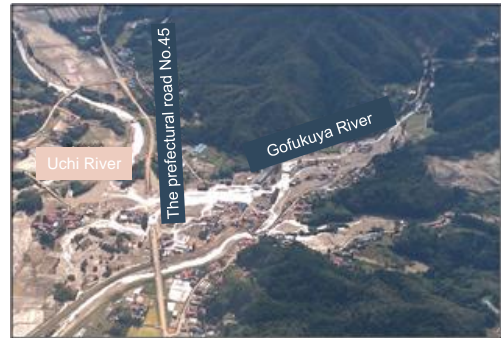
In the midstream of the Gofukuya River, bank erosion or bank collapse occurred in most of the section where there are no bare rocks. In the Usudaira flat ground area (about 3 km from the Uchi River junction), the river channel was mostly clogged with sediment, which is considered to show the occurrence of sediment / flood inundation.

**Photo 6 Occurrence of sediment / flood inundation in the Gofukuya River (Oct. 17)**

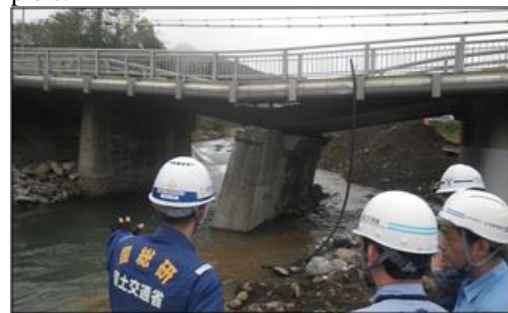
In the Hounji Bridge of the National Highway No. 20 (Otsuki-shi, Yamanashi), two bridge piers that were supported by the spread foundation subsided and tilted and the road was blocked due mainly to the subsidence of the girders that were supported by these piers.

**Photo 7 Giving technical advice (Oct. 21)**

We conducted a field survey on October 21 upon request from the Kanto Regional Development Bureau and gave technical advice on the status assessment and emergency restoration method of the bridge after the damage (Photo 7).

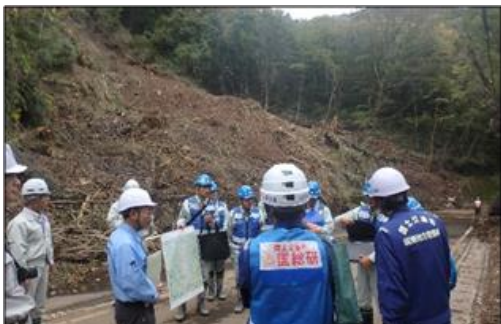
On the National Highway No. 138, a natural slope at Hakone-machi, Kanagawa, collapsed about 180 m upward the road (oblique distance along the slope) and the traffic of the section including this spot was blocked. In response to the request from Kanagawa-ken, we conducted a field survey on October 26 and gave technical advice on the mechanism of slope failure and emergency recovery of the road (Photo 8).

**Photo 8 Field survey on National Highway No. 138, Hakone-machi. (Oct. 26)**

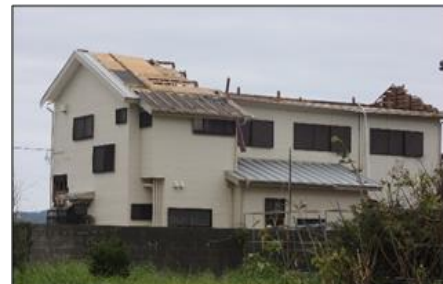
As for types of damage to houses, there were breakage of windowpanes, come-off of roof tiles and other roofing, scattering of wooden roof truss (Photo 9), partial come-off, scattering, etc. of exterior wall finishing material (lath mortar, etc.). Of the above,

relatively major damage was selectively caused to those comparatively aged, those located along the coast, those of which component parts considerably deteriorated or suffered termite damage, etc.

**Photo 9 Scattering of the roof truss of a wooden house (Sep. 12)**

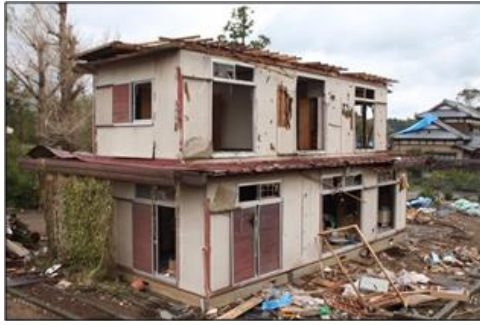
As damage to houses, two cases where the upper structure fell down or scattered were confirmed. In both cases, the house aged more than 50 years. As damage other than collapse of super structure, etc., there were damage to the openings and exterior walls, scattering of wooden roof truss, come-off / scattering of tiles, deformation of the fittings facing outside, etc. (Photo 10) There was also a case of damage expansion where the fittings of storm shutters, etc. were damaged by collision of flying objects and the wind blew into the room, although the storm shutters were closed to prepare for approach of the 2019 East Japan Typhoon.

**Photo 10 Damage to the roof, openings, etc. of a house (Oct. 15)**

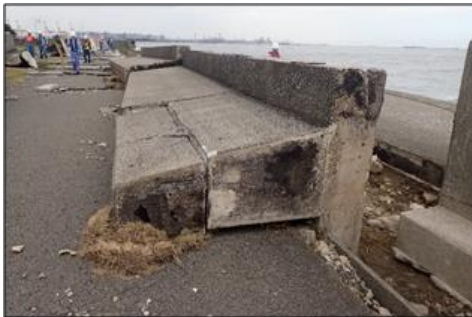
The superstructure of the east side revetments in the Yokohama Port Honmoku Futo district collapsed intermittently about 200 m in length. Since all the superstructures collapsed to the inland side, high waves are considered to be the cause (Photo 11). In addition, the container terminal was inundated and part of the fence collapsed. According to the trace of inundation, the inundation depth at the container terminal seemed to have been about 1m.

**Photo 11 East side revetments in the Honmoku Futo district (Sep. 14)**

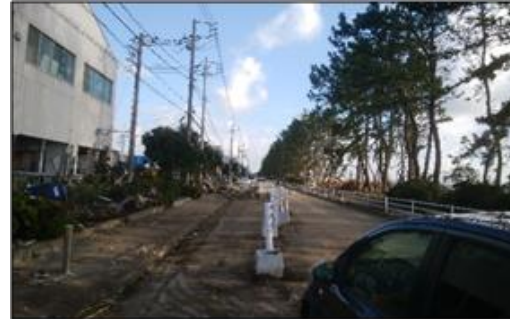
East side revetments of Fukuura and Sachiura in the Yokohama Port Kanazawa district suffered damage, and the superstructure of the revetments collapsed intermittently about 600 m in Fukuura and about 230 m Sachiura. In some area, subsidence of the revetments was also confirmed. Since all the superstructures collapsed to the inland side, high waves are considered to be the cause.

located, and the whole area of these industrial complexes were flooded. According to the trace, it seems that sea water flew into the back a maximum of 800 m away from the revetments and that the inundation depth was a maximum of about 2 m near the revetments of Fukuura (Photo 12).

**Photo 12 Back of the Fukuura revetments in the Kanazawa district (Sep. 12)**
