A Study for Early Restoration of the Road Bridge Damaged by the Earthquake

Research Center for Infrastructure Management, Kumamoto Earthquake Recovery Division

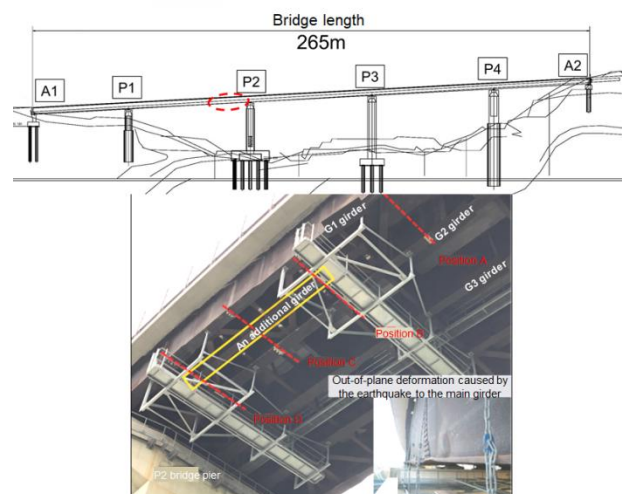
As the damage to the Okirihata Bridge, a steel 5-span continuous non-composite curved plate girder bridge, 265 m in length, the top structure moved on the whole in the direction outside the curve and part of the main girder collapsed. It is particularly characteristic that the damage to the main girder occurred at points other than the supporting point. Above all, relatively major damage, including out-of-plane deformation, occurred to two main girders (G1 girder, G2 girder) outside the curve between P1 and P2.

Fig. 1 Additional girder installed in restoration of the Okirihata Bridge

to the main girder at a point other than the supporting point, it is generally considered to remove or reconstruct the whole main girder or damaged part. In this paper, however, a main girder ("additional girder") cross-sectional rigidity enough to supplement the load bearing capacity of the main girder, which was lowered by the damage, was installed (Fig. 1), while strategically leaving the greatly damaged main girder, considering mainly that at least the load bearing capacity enough to support the weight of floor slab etc. is kept since no damage or deformation is increasing after the earthquake and that there is uncertainty in the extent of effect of the stress remaining in the component on other components when the main girder is removed.

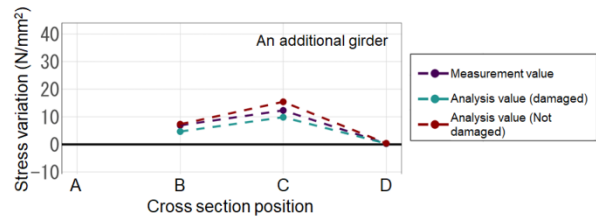
functioning as a resistance cross section, we compared results of two analyses for monitoring results --- one is where the damaged part also functions as a resistance cross section (not damaged) and the other is where it does not function (damaged). As Fig. 2 shows, it was found from the results of comparison that the additional girder is functioning as a resistance cross section expected in the design since the measured values of stress variations were between the values of two analyses in an expected range.

Fig. 2 Stress variation in jack-down of the additional girder

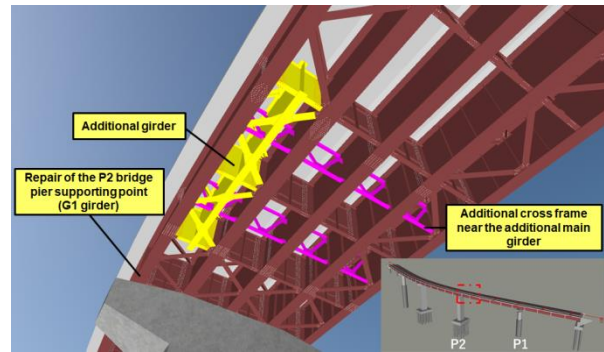
First, based on the existing two-dimensional structural general drawing, we created a three-dimensional model of the whole structure with detailed degree of 300¹⁾, which accurately represents the outer shape. Next, we created a model for additional components, including additional girder, additional cross frame, and remaining temporary cross girder, installed when supporting the bent (Fig. 3). Note that additional components are indicated with colors so that difference from existing components is easily recognized.

Fig. 3 Three-dimensional model of the Okirihata Bridge (near the additional girder)
