Analysis of the Impact on Traffic Functions of Scouring of Road Earthwork Structures and Slope Collapses, Etc. Due to Torrential Rain

Pavement and Earthworks Division, Road Structures Department

(Keywords) road earthwork structures, scouring, torrential rain, slope collapse, road function

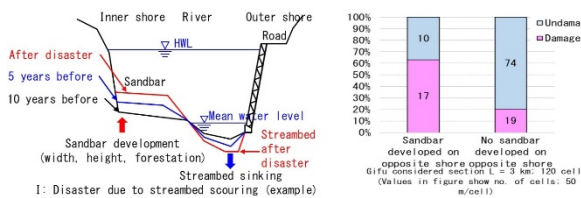
When grasping the state of streambed scouring, directly confirming scouring locations is not easy if the water flow is great, so we focused on the development of sandbars, which is one cause of streambed sinking, and analyzed changes to sandbars over time through past aerial photographs as a comparative easy method. As a result, the proportion of locations that suffered damage was roughly tripled if the location had a sandbar develop on the bank opposite the damaged location, compared to locations without a sandbar (fig. 1). Because of this, observing changes in sandbars over time appears to be effective as one method of inspecting to ameliorate the risk of damage.

Fig. 1. Example of scouring damage due to sandbar development

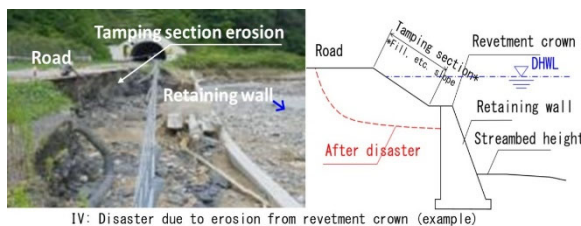
As a result of an analysis focusing on the disaster water level in the event of torrential rain (DHWL) and the revetment structures, structures with tamping above the revetment crown were damaged more easily than structures without it (fig. 2), and damage occurred in all locations when the water level in flood exceeded the revetment crown. In future, it is necessary to consider countermeasures incorporating conditions with a high likelihood of disaster, as there are many similar locations.

Fig. 2. Example of damage during water level rise due to torrential rain
