Field Survey of earthquake and tsunami of Sumatra Mentawai Islands in 2010

KUMAGAI Kentaro, Senior Researcher
Coastal and Marine Department

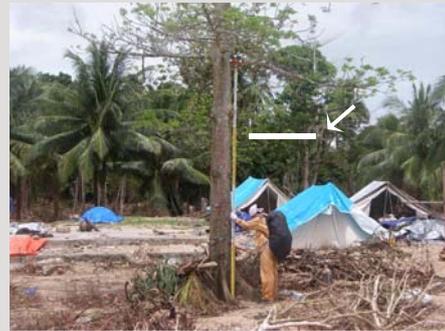
Photo 1. Measuring trace height (white line shows trace height)

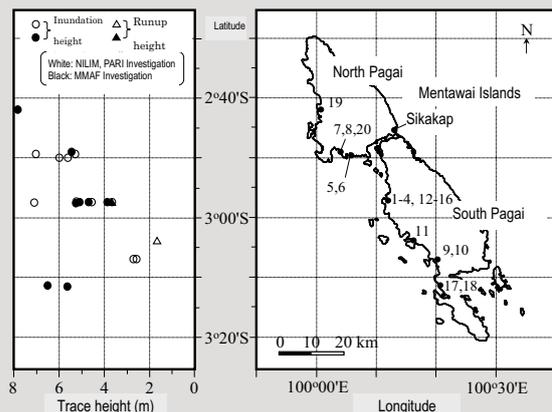
Figure 2. Distribution of Trace Height of Tsunami

Tsunami with height of about 6m above sea level struck North Pagai and South Pagai Islands, and damaged buildings. Brick houses were completely destroyed. At several villages, the tsunami reached between 7 and 8m in height (Fig. 2).

1-4, 12-16: Malakopa 5, 6: Muntebarubaru 7, 8, 20: Sabeungkung 9, 10: Saumang, 11: Bake, 17, 18: Bulasat, 19: Silabu
