Research Trends and Results

The damage evaluation technique from the point appearance for the highway steel bridge heat affected by a fire

Bridge and Structure Division, Road Department

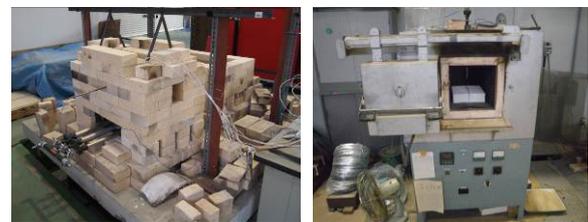
Fig. 1 Gas furnace Fig.2 Electric furnace

Test specimens were two kinds of steel plates. The first was a specimen with five kinds of coating which are generally adopted in Japan were prepared. The other that was cut out from a removed bridge was prepared. The two was tested in the furnaces as shown in Figure 1 and Figure 2, a gas furnace and an electric furnace in order to investigate the relationship between the supply of oxygen and damage to the painted steel after the test.
