Technological support for damage to the National Route 186 Noboritani Snow Shelter

Foundation, Tunnel and Substructures Division, Road Structures Department

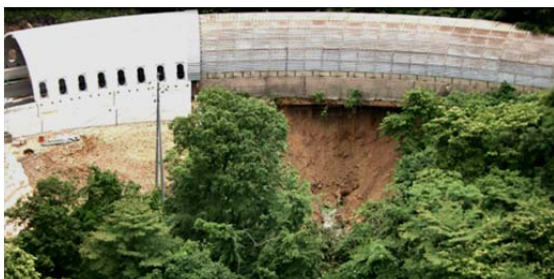
At the snow shelter, the valley side of the embankment collapsed for about 20 meters in height, approx. 20 meters in width, and about 2 meters in depth. Some of the discharge pipes installed inside the embankment were damaged and exposed.

A possible cause of the damage was that a large volume of water entered the embankment from the discharge pipe joints, which accelerated the outflow of sediment from the embankment or erosion of the top of the slope and triggered the slipping and collapse of the embankment.

Photo 1: The entire view of Noboritani Snow Shelter and damaged section

Additional rain may cause the collapse of the entire foundation. Thus, the researchers advised that the slope and collapsed sections should be covered with blue sheets to prevent them from being directly exposed to rain and to stop the outflow of sediment from the discharge pipes as emergency measures.

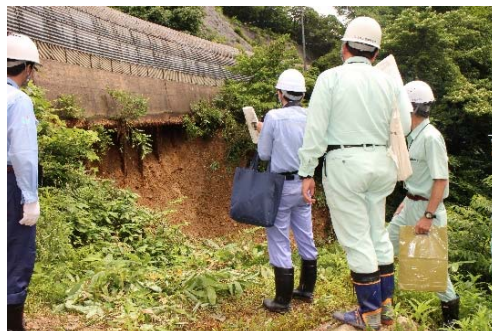
The embankment was valley fills into which water easily penetrated. The inspection of the intake part of the discharge pipes found the accumulation of sediment and driftwood and a trace of a raised water level on the upstream side. Although there was no major change to the pavement surface inside the snow shelter, the inspection found a gap between the asphalt surface and the roadbed.

Photo 2: On-site inspection at Noboritani Snow Shelter
