# Field Survey on Disaster at the Tachikawa Bridge of Kochi Expressway

KIMURA Takashi, Researcher NANAZAWA Toshiaki, Head, Foundation, Tunnel and Substructures Division, Road Structures Department

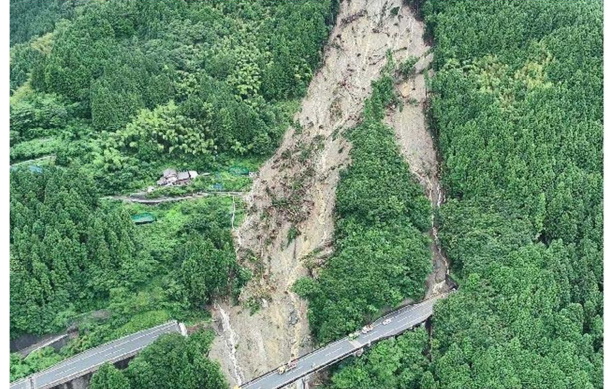
Disaster situation (source: West Nippon Expressway Company Limited)

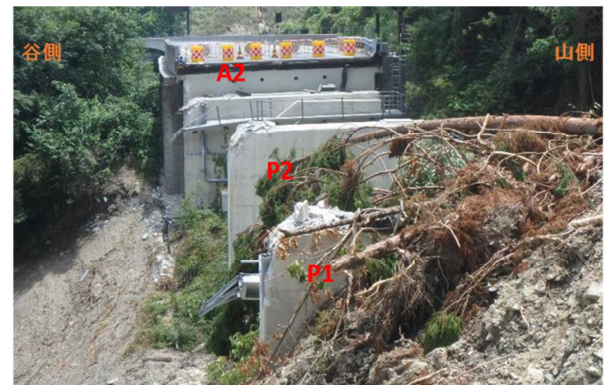
It is considered from the aforementioned situation of damage that the effect of large-scale collapse acted on the superstructure and caused run-off.

Superstructure run-off

We advised the personnel on the site that they needed to check soundness of the substructure by removing the sediment deposited on the slope and to consider measures for training of the space under the bridge girder for recovery.

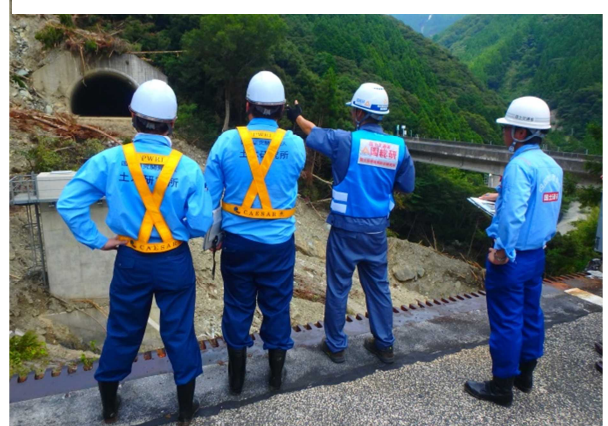
Field survey
