Contribution to Early Restoration of the Road Bridge Damaged by the Kumamoto Earthquake with Comprehensive Technical Capability

HOSHIKUMA Jun-ichi (Ph. D.), Head, NISHIDA Hideaki, Senior Researcher, TAKIMOTO Kodai, Researcher, Kumamoto Earthquake Recovery Division, Research Center for Infrastructure Management

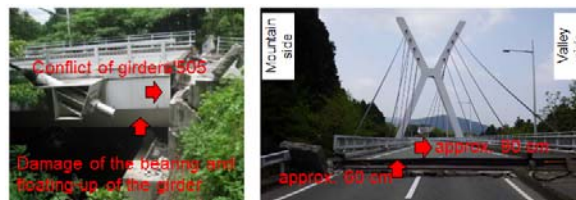
Kuwazuru Bridge is a two-span continuous cable-stayed steel bridge, 160 m in length, with a curved girder hanging, of which span is different by 40 cm at the starting point and ending point from X-type main tower. As shown in Fig. 1, the girder end at the bridge end floated up about 60 cm due to damage to the bearing caused by the Kumamoto Earthquake and the entire girder moved about 90 cm to the valley.¹⁾ In addition, tension of the cable was lost in part and the cable got twisted.¹⁾

Fig.1: Main damage to the Kuwazuru Bridge

For restoration of the Kuwazuru Bridge, proposal for "Build Back Better (better restoration)" was made based on disaster situation and maintenance after restoration and with various technical considerations. Specifically, we proposed the countermeasure technology for preventing floating-up of the girder against the earthquake exceeding the size expected by design, monitoring method in construction stage for rectifying the uncertainty of restoration design, multiple considerations for preventing water permeation into the cable fixing part, etc., which were all adopted.²⁾
