Construction standards and promulgation technologies that can respond to needs of the society

FUKUYAMA Hiroshi (Ph.D. in Engineering), Director, Building Department

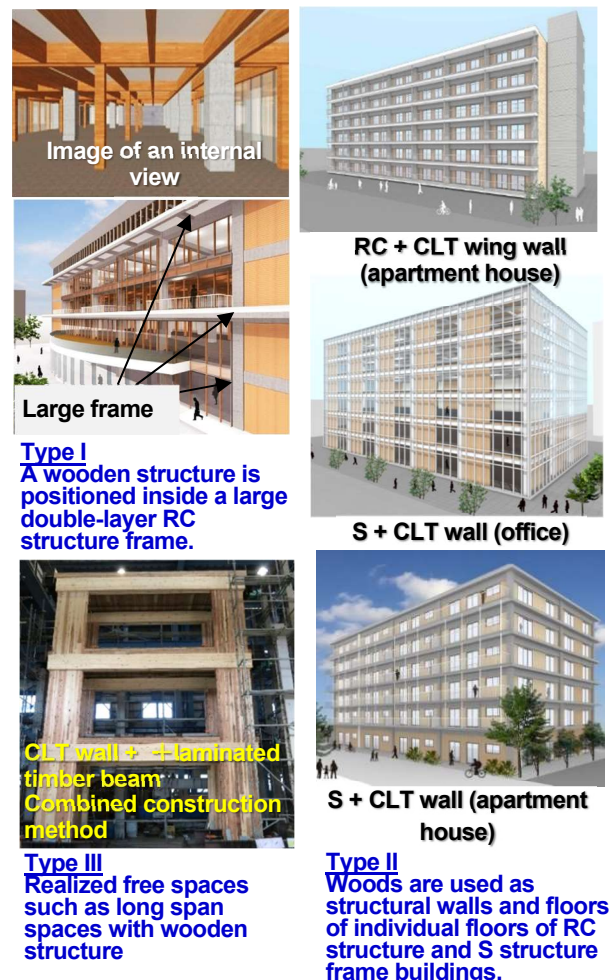
RC structures and steel structures. In particular, creating a space where wooden materials are visible on the surface of the interior used to be difficult in mid-to-high-rise buildings. Yet, the project will present multipurpose design methods and bonding methods that can realize the necessary structural performance and durability by actively using the newly revised fire safety and evacuation regulations. These will be organized as three types of prototype architectural design examples, which are to be spread as general technologies (Figure).

Figure: A prototype building under consideration

Here, a new architectural space is created by using CLT, large-scale wooden panels, and other wooden materials as structural members and combining them with

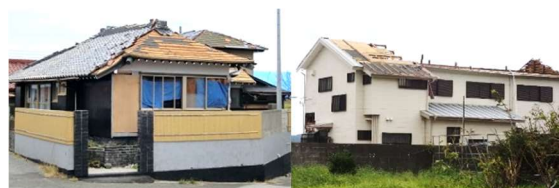
Our on-site investigation of damage caused by Typhoon #15 (Faxai) found that significant damage was seen in window glass, roofing materials such as tiled roofs, wooden roof trusses, exterior finishes, outdoor fittings, eave soffits, and other parts of houses and low-rise retail stores.² Focusing on damage (photos) to

roofing materials, wooden roof trusses, and outdoor fittings (large sash),

Scattering of roofing materials

Damage to roof trusses

Outdoor fittings of stores
Damage and collapse of large sashes

Photo: Various building damage caused by strong winds

1) Roofing material: Observed damage caused by factors that include roofing materials installation methods (mainly fitting and binding methods) and the causes of the damage are examined to select and establish recommended methods to be used widely. Also, the diagnosis and renovation methods used on currently installed roofing materials and the wind resistance performance ranking of roofing materials are examined to find ways to guide the industry to more robust roofing.

2) Roof trusses: Examples of the specification for roof trusses based on standard wind speed will be proposed by conducting stress experiments using test specimens that reflect the actual conditions of roof beams and roofing boards.

3) Large sashes: Stress tests and evaluation methods will be developed by identifying the actual strength at the joint sections between a large sash and the building frame to present recommended specifications.
