# Research on Technology to Grasp the Conditions of Slopes Close to Roads Early after an Earthquake

(Research period: FY2019 to FY2021)

Research Center for Infrastructure Management, Kumamoto Earthquake Recovery Division,

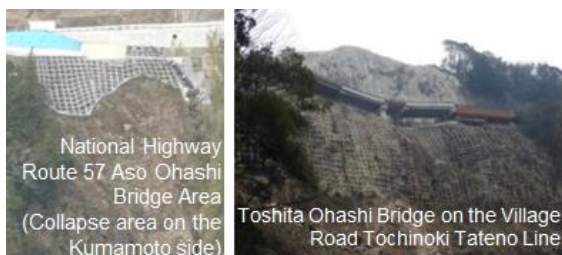
**Photo 1: Road close to the steep slope**

In the 2016 Kumamoto Earthquake, the functions of roads were affected by ground deformation, and some of these roads took a long time to investigate and restore because they were located close to steep slopes (**Photo 1**). Based on this lesson, in order to make decisions as quickly as possible on whether roads along such slopes are passable or not immediately after an earthquake and on emergency opening, it is considered that one of the most important factors is the early and comprehensive grasp of the existence, extent, and degree of deformation on the slopes. Therefore, in order to present a maintenance management method that contributes to the early and comprehensive grasp of the deformation of road slopes that are not easily accessible, we are studying the possibility of using existing technologies to detect deformations and the matters etc. that should be considered when acquiring data and interpreting the acquired information for implementation in maintenance. This paper reports the knowledge obtained based on the measurements made on the restoration sites of the Kumamoto Earthquake with regard to the issues that should be considered in implementation.

This paper provides the results of three times of measurements made in March, August, and November at the lower slope of the Toshita Ohashi Bridge (**Photo 1, right**), where the progress of restoration work and vegetation conditions were different. In the measurement, we used two types of laser scanners, i.e.,

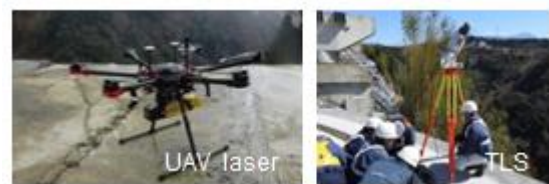
**Photo 2: Technology used in the study**

UAV-mounted laser scanner and terrestrial laser scanner (TLS), as a technique that has the potential to grasp the shape of steep slopes in planes without close proximity (**Photo 2**).
