### ■ A Public Experiment on Debris Flow: Approaching Mechanism of the Driftwood Disaster Occurrence

Sabo Department, Sabo Planning Division

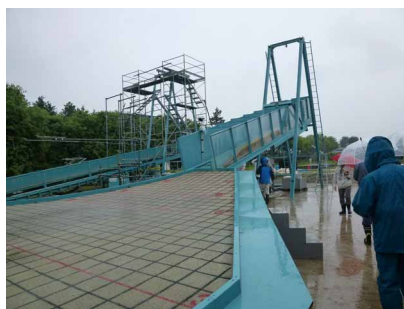
Photo 1: Experiment channel

Disasters occurred in Izu-Oshima in October of last year and in Aso in 2012, including frequent severe sediment disasters. The Sabo Planning Division has conducted surveys and research on debris flow and driftwood flow and inundation phenomena and methods of countering these phenomena. Among these, experiments using channels, models, etc. are useful methods of clarifying debris flow mechanisms. In June, that is also sediment disaster prevention month, part of the experiments were carried out publicly for members of the press. The experiment was done by mixing sediment and driftwood in a debris flow to confirm the way the debris flow flowed and inundated the land (Photo 1).

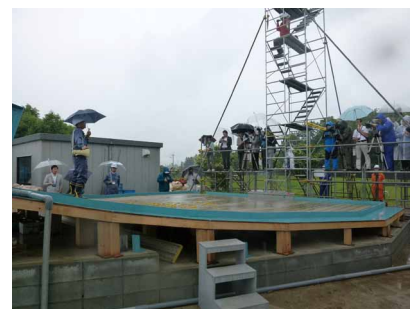
Photo 2: View of the public experiment

The experiment was done in the presence of many members of the media during rainfall on the afternoon of June 9 (Photo 2). On the day of the public experiment, two different experiments using sediment with different particle sizes including driftwood were conducted. In the experiment

case including a large quantity of fine particle size sediment, the driftwood was carried further in the direction of the debris flow, but in the experiment case not including a lot of fine particle size sediment, the driftwood spread out laterally. This experiment has revealed that differences between sediment can impact the inundation of a debris flow containing driftwood. The Sabo Planning Division will analyze these results at the same time as it carries out surveys of actual conditions and a study based on numerical calculations etc. to improve debris flow and driftwood inundation prediction technologies.

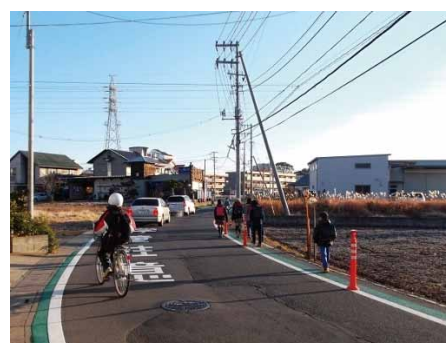
Photo: View of the Public Experiment

The social experiment was done in sections where it is difficult to install sidewalks because the road is too narrow, sections which are somewhat wide, but many vehicles travel through at high speed, and streets used by through traffic, by widening or coloring shoulders (where people walk), or by installing structures to slow traffic such as hump (raised road surface) or chicanes (narrowing and adding curves to force vehicles travelling through to swerve

to the left and right) or by adding road indicators or constrictions to keep traffic from entering the sections and their effectiveness was surveyed.

As a result, a questionnaire survey was conducted, and about 70% of children using the routes to commute to school responded, "I can now walk with confidence." At the same time as it was confirmed that traffic speed fell in humped sections, it also confirmed that in chicane sections, about half of morning

traffic slowed to meet and pass oncoming vehicles. And about 40% of the drivers traveling on the streets responded, "I drove more carefully than usual when I realized it was a school route."
