Outline of the Survey of Damage Caused by the Niigata Chuetsu Offshore Earthquake of 2007

Winter 2007

国総研ニューズレター NILIM News Letter

平成 19 年新潟県中越沖地震被害調査概要

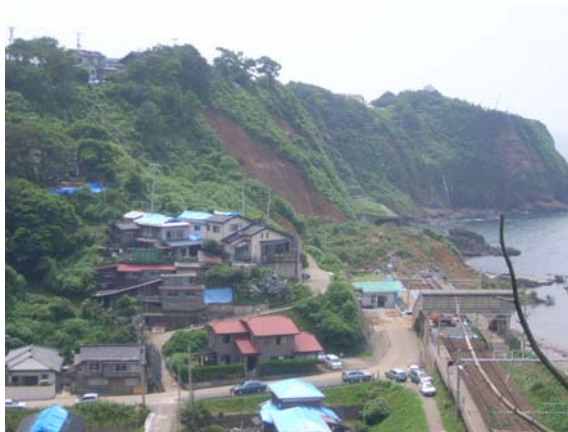
写真-1 柏崎市青海川地先の地すべり
Photo 1. Landslide on the Omi River Frontage in Kashiwazaki City

柏崎市青海川地先では、写真-1に示すように、地すべり(幅約65m、長さ約45m)の滑落によって生じた土塊がJR信越本線の軌道上に堆積した。また、柏崎市米山町聖ヶ鼻地先では、尾根の頂部に落差10m程度の滑落崖を有する地すべり(幅約60m、長さ約110m)が生じた。

On the frontage of the Omi River in Kashiwazaki City, a mass of soil created by a landslide slip (approx. 65 m wide and 45 m long) was deposited on the tracks of the JR Shinetsu Main Line as shown in Photo 1. At the Hijirigahana frontage in Yoneyama Machi in Kashiwazaki City, a landslide with a slip scarp and drop of 10 m occurred at the top of a ridge (60 m wide, approx. 110 m long).

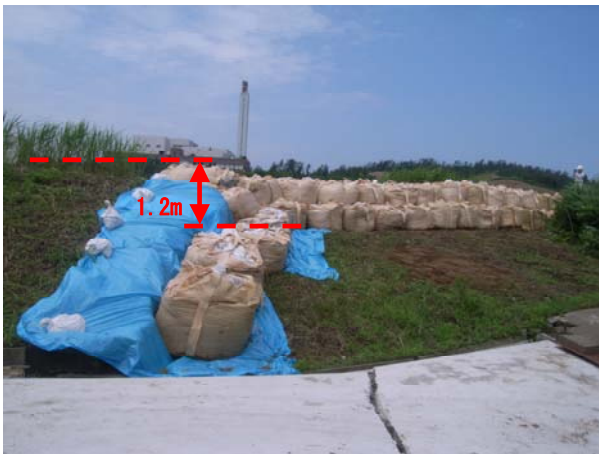
信濃川本川0kp付近左岸(長岡市町軽井)では、堤防が最大約70cm沈下するとともに、裏小段及び川表側の坂路・法尻に縦断亀裂が生じた。裏小段と川表側の法尻には液状化痕が確認された。また、鯖石川2kp付近左岸(柏崎市橋場町)では、延長80mにわたり、横断亀裂を伴う堤防天端の沈下が生じた(写真-2)。沈下量は最大1.2mである。川裏側の法尻付近には噴砂痕が確認された。

写真-2 鯖石川2kp付近左岸の横断亀裂を伴う沈下
Photo 2. Settlement caused by lateral cracking on the left bank near 2kp on the Sabaishi River

On the left bank near 0 kp of the main course of the Shinano River (Machikarui in Nagaoka City), the levee settled a maximum of 70 cm and longitudinal cracks appeared on the river side terrace, while on the side facing the river, cracks appeared on the slope road and the toe of the slope. Signs of liquefaction were found on the river side terrace, and on the toe of the slope facing the river. On the left bank near 2 kp of the Sabaishi River (Hashibacho in Kashiwazaki City), the crest of the levee settled accompanied by lateral cracking for a distance of 80 m (Photo 2). The settlement reached a maximum of 1.2 m. Signs of sand boiling were found near the toe of the slope on the landslide.

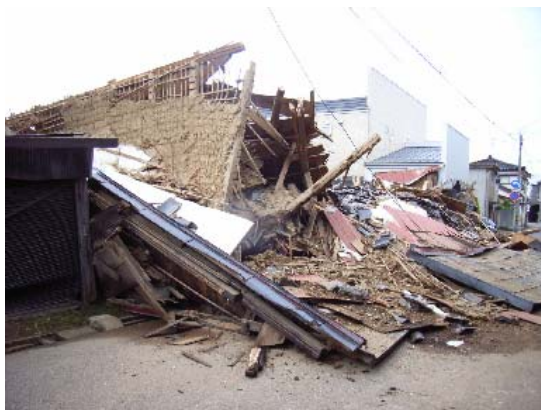
被害を受けた建築物の大半は木造であり、土塗り壁を有するような比較的古い構法による住宅、倉庫、車庫、納屋の類、並びに店舗併用住宅が選択的に大破（写真-3）、倒壊（写真-4）していた。特に柏崎市東本町3丁目付近や新花町付近では、倒壊家屋が多く目立った。刈羽村刈羽、柏崎市田塚などでは、一部に液状化するなどの地盤の被害も見られた。

写真-3 倒壊した古い木造家屋（柏崎市四谷）
Photo 3. Collapsed old wooden building
(Yotsuya in Kashiwazaki City)

Most of the damaged buildings were wooden: dwellings, storehouses, carports, or barns, constructed by relatively old structural methods such as mud coated walls plus combined residential/business premises were severely damaged (Photo 3) or toppled (Photo 4). Near Higashihoncho 3-chome and near Shinhanacho in Kashiwazaki City in particular, many buildings collapsed. In Kariwa in Kariwamura and in Tatsuka in Kashiwazaki City, damage to ground such as localized liquefaction occurred.

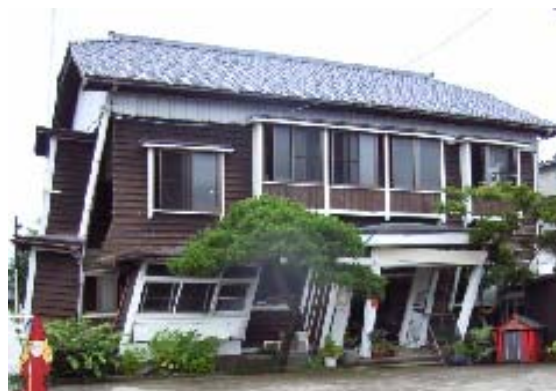
写真-4 大破した木造家屋（柏崎市東本町）
Photo 4. Severely damaged wooden home (Higashihoncho in Kashiwazaki City)

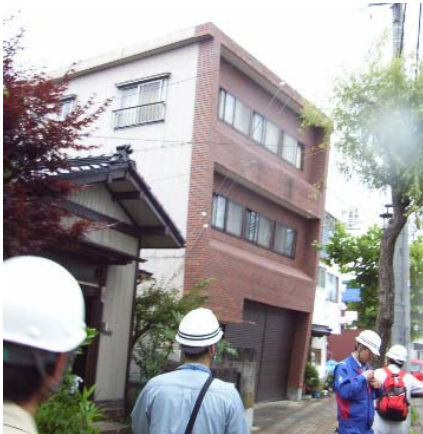
非木造建築物の被害としては、鉄骨造建築物の一部に目視で判別できる程大きな残留変形を有する被害例（写真

Damage to non-wooden buildings included a case of residual deformation so large that it was visible on part of a steel frame

-5) や、内外装材の崩壊等が確認されたほか、地盤の被害に伴う傾斜の残留などが確認された。また、柏崎市橋場町にあるゴミ焼却場では鉄筋コンクリート造の煙突の被害(写真-6)を確認した。

写真-5 大きく傾いた鉄骨造建築物
Photo 5. Steel-frame building leaning sharply

building (Photo 5) and the collapse of interior and exterior finishing, plus residual inclination caused by ground damage. At

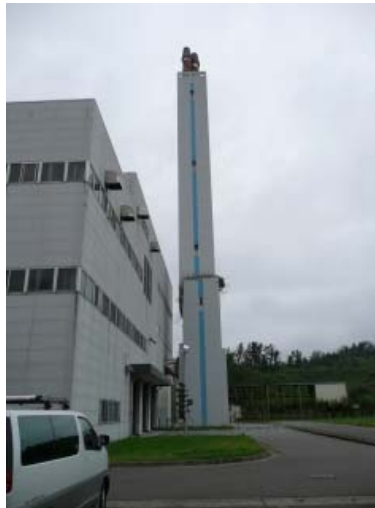
写真-6 大きな被害を受けた鉄筋コンクリート造の煙突
Photo 6. Severely damaged reinforced concrete chimney

a garbage incineration plant in Hashibacho in Kashiwazaki City, a reinforced concrete chimney was damaged (Photo 6).
