Case 1

Matsuki Hillside Work

Case 2

Oya Hillside Work

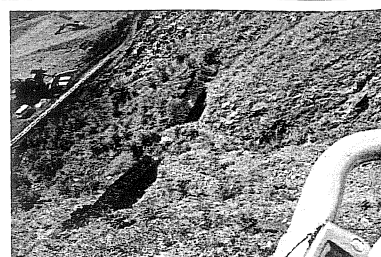
(Photo 1) State of vegetation on the slope: Recovery of vegetation caused by natural invasion is seen at the location where sediment movement is controlled above small check dam work.

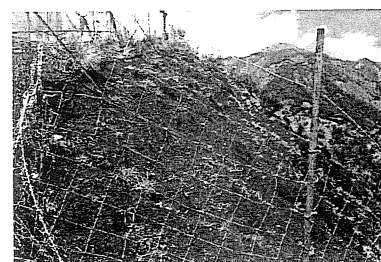
(Photo 3) Measure to prevent damage by deer: A protective net installed to prevent damage by Japanese serow and Japanese deer.

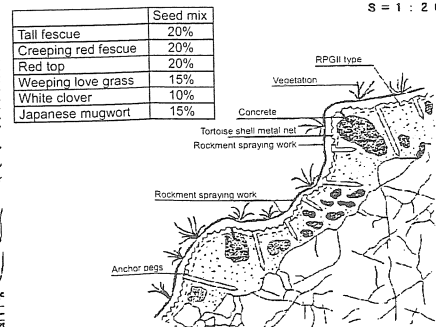
Rockment Spraying Work (sprayed 6kg/m²) Materials Table

Item	Standard	Unit	Quantity	Remarks
Rockment	Mix 1:3:3	kg	600	
Iron wire mesh	Wire diam: 1.2mm, mesh size: 10mm	m ²	120	
RPG type II	Thickness: 1.0mm, diameter	m ²	110	
Anchor pegs	Diameter: 13mm X 600mm	-	60	
Anchor pegs	Diameter: 13mm X 400mm	-	60	
Anchor pegs	Diameter: 9mm X 200mm	-	300

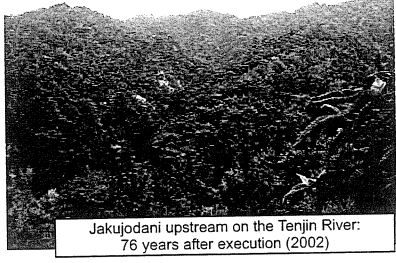
Jakujodani upstream on the Tenjin River: 76 years after execution (2002)
