## Reports on Damage to Buildings, etc. brought about by the Tornado which hit Tsukuba, Ibaraki on May 6, 2012

OKUDA Yasuo, Research Coordinator for Disaster Mitigation of Buildings (Dr., Engineering)  
Research Center for Disaster Management

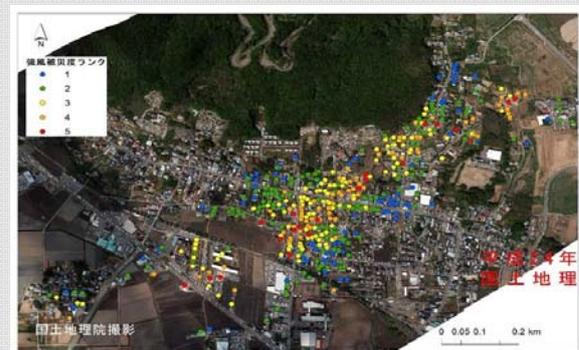
Damage distribution map Fig. 1.

The Tsukuba city office has reported the damage, 1casualty, 37 injured, 210 totally collapsed buildings, 47 mostly collapsed, 197 half collapsed and 639 were partially damaged. Both NILIM and BRI have classified those buildings as damaged by the gusty wind focusing on the Hojo area of Tsukuba city and made the Damage Distribution map Fig. (1).
