Analysis of the Impact on Traffic Functions of Scouring of Road Earthwork Structures and Slope Collapses, Etc. Due to Torrential Rain

Pavement and Earthworks Division, Road Structures Department

(Keywords) road earthwork structures, scouring, torrential rain, slope collapse, road function

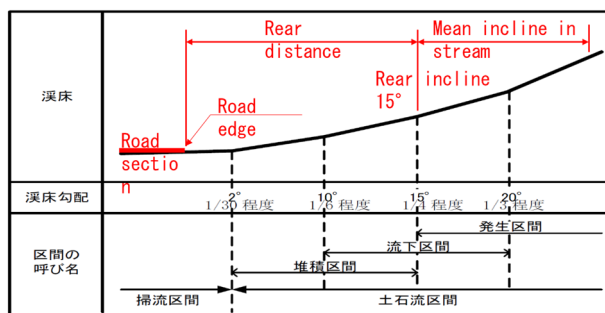
Fig. 3. Settings for matters for organizing sediment

We analyzed disasters due to sediment inflow, organizing them by the catchment area of the stream, distance, etc. In relation to the stream incline, we used the streambed incline for the manner of sediment movement (fig. 3) as a guide, and focused on an incline of 15° for the accumulation section, at which sediment begins to accumulate, established a rear incline, incline distance, and mean incline in stream as shown in red in figure 3, and organized the section distances between them.
