Development of System for Detecting Damages by Earthquake Projected on CCTV Camera Images

(Research period: FY2014 to FY2018)

KONNO Arata, Researcher, ASHIYA Hideyuki, Research Coordinator for Advanced Information Technology, SEKIYA Hirotaka, Head, ITOUJI Toshiro, Senior Researcher, MORITA Kenji, Guest Research Engineer
Information Platform Division, Research Center for Infrastructure Management

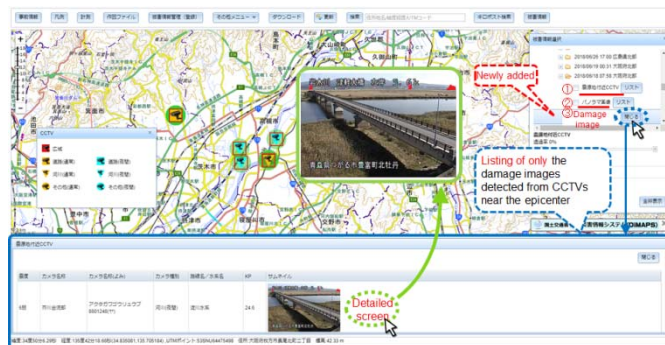
Fig. 1: DiMAPS screen after the communication test

DiMAPS is a GIS that can collect disaster information from the site and display it on the map clearly. Fig. 1 shows a screen that could be displayed as a result of the communication test conducted on February 8, 2019 between the System and DiMAPS. To display images created by the System, select the layer of "Damage images" on the right of the screen and then a list of thumbnail images of CCTV cameras that detected a "difference" on the System is posted on the bottom of the screen. Enlarged images as shown in Fig. 2 are available by selecting "Detailed screen" of the CCTV camera image that needs to be checked in detail. The System has a function to color the field in

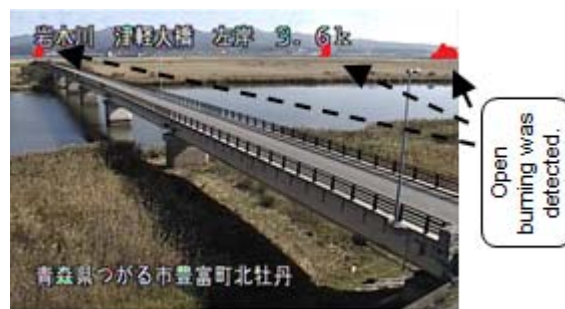
Fig. 2: Example of the image created by the System

red where a "change" that may represent damage was detected. In the example of Fig. 2, open burning at a distant location was detected from the river monitoring camera.
