# No.21

## Summer 2007

# 国総研ニューズレター NILIM News Letter

## Outline of the Survey of Damage by the Noto Hanto Earthquake of 2007

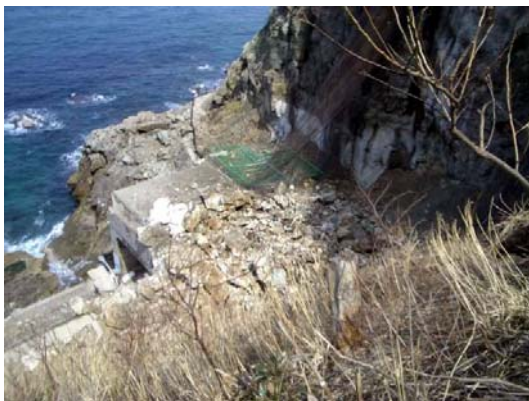
写真 1 岩盤の崩落地付近から見た八世乃洞門の被災状況

Photo 1. Damage to the Haseno Rock Shed

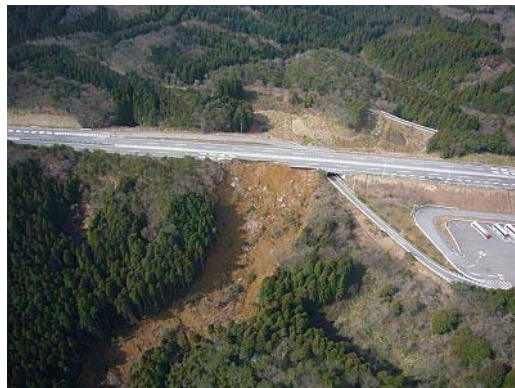
写真 2 別所岳 SA 近傍の盛土崩壊（能登有料道路 17.7kp 七尾市中島町田岸）

Photo 2. Collapsed Embankment near the Bessho-dake Service Area (17.7 kilometer point on the Noto Toll Road, Nanao City)

今回の地震で多くの盛土被害が生じた能登有料道路は、金沢市と穴水町を結ぶ延長 82.9km の山岳道路である。能登有料道路の別所岳 SA 近傍 17.7kp の盛土崩壊の様子を写真 2 に示す。今回の地震によ

The Noto Toll Road where the earthquake damaged many embankments is an 82.9km mountain road connecting Kanazawa City and Anamizu Town. Photo 2 is a view of a collapsed embankment at the 17.7 kilometer point near Bessho-dake Service Area on the Noto Toll Road. As a typical example of embankment damage caused by the earthquake, a high embankment with height of 30

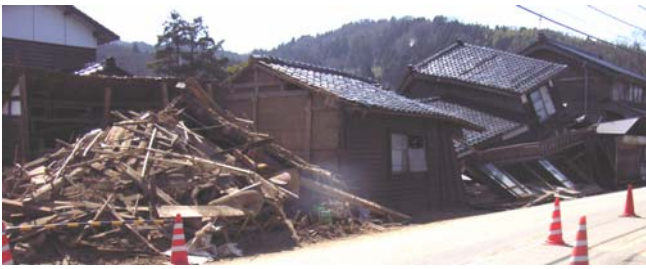
写真3 倒壊家屋が建ち並ぶ輪島市門前町館地区  
Photo 3. Row of Toppled Homes in the Tachi District in Monzen-machi, Wajima City

木造建築物の被害が大きい、もしくは被害を受けた建築物の割合が高い地域は、輪島市門前町道下、同市門前町門前・館・走出(計測震度6.4、最大加速度1303.6gal)、同市門前町黒島、同市鳳至町(計測震度6.2、最大加速度464gal)・河井町(同5.5、519gal)、穴水町大町(同6.3、780gal)、七尾市田鶴浜(同6.2、745.9gal)の順であった。輪島市鳳至、河井町周辺では倒壊家屋は数棟しか確認されなかったのに対し、同市門前町では、少なくとも門前・館・走出地区で14棟、道下地区で17棟、黒島地区で14棟の倒壊家屋を確認した。確認できた範囲で、道下地区で約1/4超、黒島地区で約15%の家屋が倒壊(写真3)、

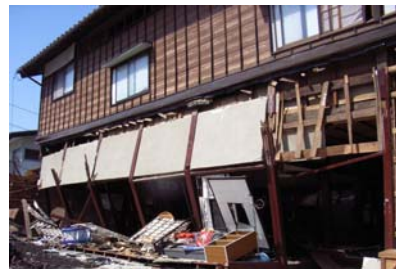
写真4 柱が折損するような甚大な被害を受けた木造家屋  
Photo 4. Wooden Houses Severely Damaged by Breakage of their Columns

または残留変形が1/10 radを超えるか柱等構造躯体が損傷(写真4)するなどの甚大な被害を受けていた。特に門前・館・走出地区や道下地区では集落周縁部の河川に近い位置に比較的大きな被害が分布していることが判明した。一方、木造の寺社建築については、倒壊を含む大きな被害を受けたものもあれば、ほぼ無被害であるものも確認された。

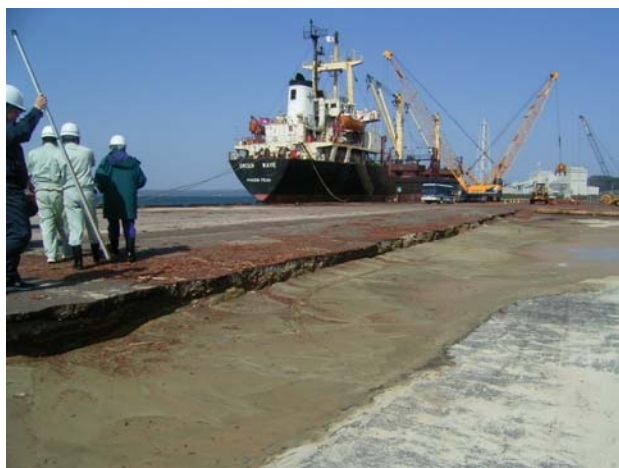
写真5 七尾港太田地区-10m岸壁(1号から2号岸壁)  
Photo 5. -10m Quaywall in the Ota District of Nanao Harbor (Quaywalls 1 to 2)

七尾港太田地区-10m矢板岸壁1号と2号(写真5)は、1号岸壁エプロン背後の埠頭用地に液状化による噴砂が堆積しており最大50cm程度の段差が発生している。2号岸壁は、目視では健全であり被災当日も木材の荷役が実施されていた。1号、2号で被災程度に大きな差が出ており、埋立土砂(浚渫砂)の違い等、今後の調査による原因究明が必要と考えている。

At -10m sheet pile quaywalls No. 1 and No. 2 in the Ota District of Nanao Harbor (Photo 5), a sand boil produced by liquefaction was deposited on the wharf site behind the apron of No. 1 quaywall, resulting in a level difference with maximum height of 50cm. The No. 2 quaywall appeared to be in good condition and it was used to load wood on the day of the disaster. At No. 1 and No. 2, the degree of damage differed greatly, and it is necessary to clarify the causes—differences in landfill soil (dredged sand) for example—by future surveys.

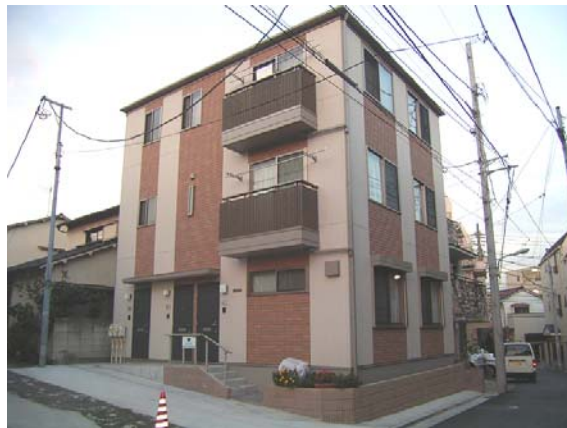
写真 道路斜線制限等の緩和を受け総3階で建替った建物の例（東京都品川区戸越一丁目）  
Fig. An example of a building rebuilt with 3 full stories with a variance of height controls to a front road, and so on (1-chome, Togoshi, Shinagawa Ward, Tokyo)
